## Safety Alert

ARTC No. 126  
Issued 31/08/2020

### Loose Wheel Nuts and ARTC Vehicles

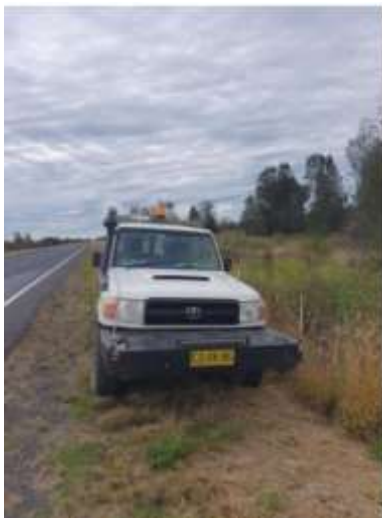
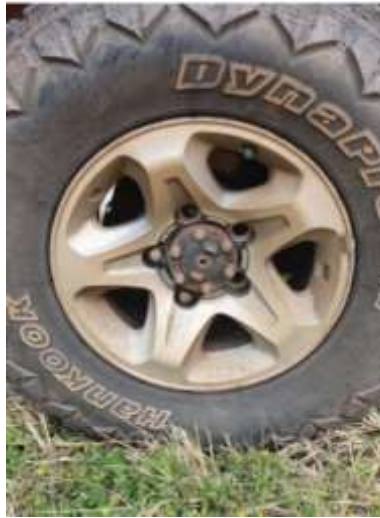
### Rims (Non-Compliant) - **X**

This alert has been issued to raise awareness of an incident where a team member was travelling along the Kamilaroi Highway in a Toyota Landcruiser 70 series wagon when during the journey, the driver noticed in the passenger mirror the rear left-hand wheel was vibrating. The driver immediately stopped in a safe location and inspected the wheel which identified 3 missing wheel nuts and 2 broken wheel studs.

Initial investigation found the rims used were alloy as shown below. These are non-compliant with ARTC's rim requirements due to previous experiences with structural fatigue issues

Confirm Landcruiser's, RRV or non-RRV are fitted with the required Heavy Duty Mine Spec Kings Rims as shown below. Further information can be found via the below link, [http://www.kingwheels.com.au/index.php?route=product/product&path=65&product\\_id=408](http://www.kingwheels.com.au/index.php?route=product/product&path=65&product_id=408)

If any ARTC Landcruiser's (RRV and non-RRV) are fitted with any other rims besides the required rims. please contact ARTC's Fleet Manager Ian Newton 0447 609 051.

Arrange for wheel nuts to be checked with a tyre brace to ensure they're not loose

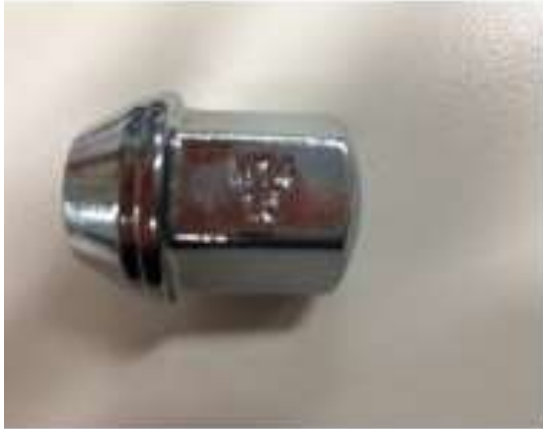
**Compliant Nut (40mm)**

- All drivers to ensure that the correct wheel nut is used – the wheel nut below is to be used with King Rims
